PROBLEMS OF QUALITY

REASONS FOR DEFECTS IN ALUMINUM MIRRORS ON SILICATE GLASS

V. I. Kozhevnikov,¹ F. Z. Gil'mutdinov,¹ and O. M. Kanunnikova¹Translated from *Steklo i Keramika*, No. 8, pp. 27–28, August, 2002.

The reasons for the formation of defects in producing mirrors in a VATT 1600-3M spraying set are analyzed. Recommendation for upgrading the set and the spraying process are given.

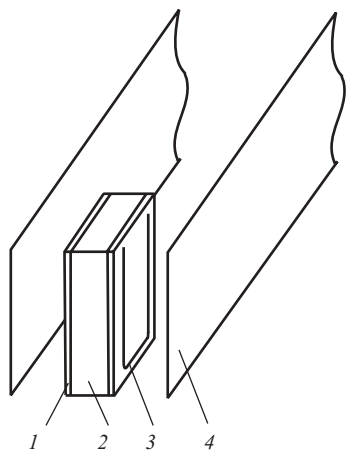
Fig. 1. Scheme of spraying of a mirror layer on glass in the VATT 1600-3M set: 1) cathode (target); 2) magnetic system; 3) anode; 4) glass for mirror spraying.

The use of the spray chamber body in the capacity of an anode ought to be recognized as an unfortunate design solution. In this case dust, hydrocarbons, and other contaminants inevitably penetrating into the chamber during the insertion of glass and adsorbed on the chamber walls impair the composition of the mirror coating.

Figure 1 shows an upgraded variant of the spraying set, in which the anode is insulated from the body. To decrease the probability of oil penetrating from the pumps into the vacuum pipelines, foreballoons and traps are usually installed in such sets. It is recommended to feed air into the chamber through a filter [4].

- to install foreballoons at the exit from the diffusion pumps;
- to replace water-chilled traps by nitrogen traps;
- to attach a dust- and moisture-trapping filter to the air-feed valve feeding air into the spray chamber;
- to insulate the magnetron anode from the body;
- to protect the mirror insulators with screens made from the target material.
